| STRUCTURE | ADVANCE AUTO PARTS |
| CUSTOMER | STANSELL CONSTRUCTION |
| DETAIL OF | BRACES |

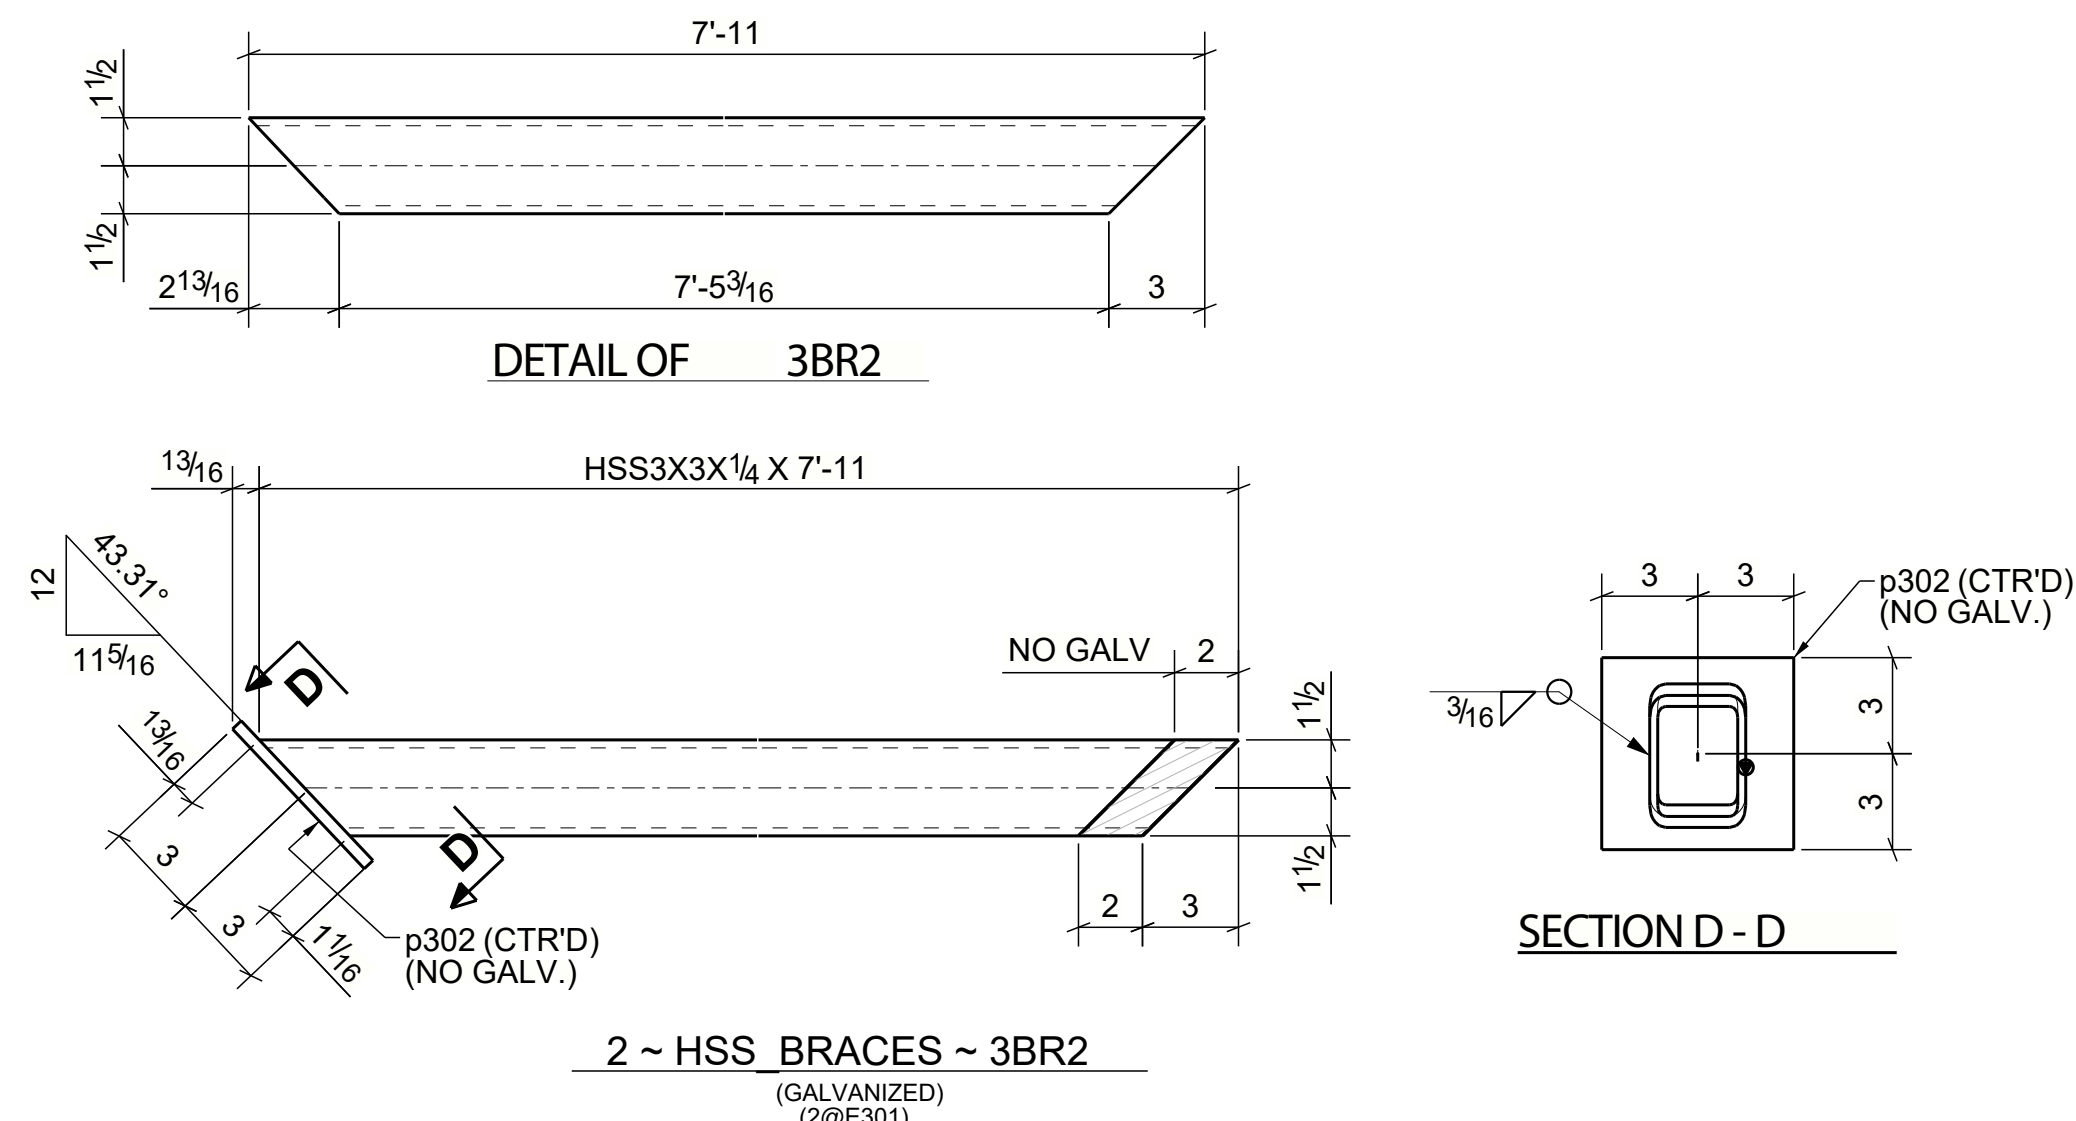
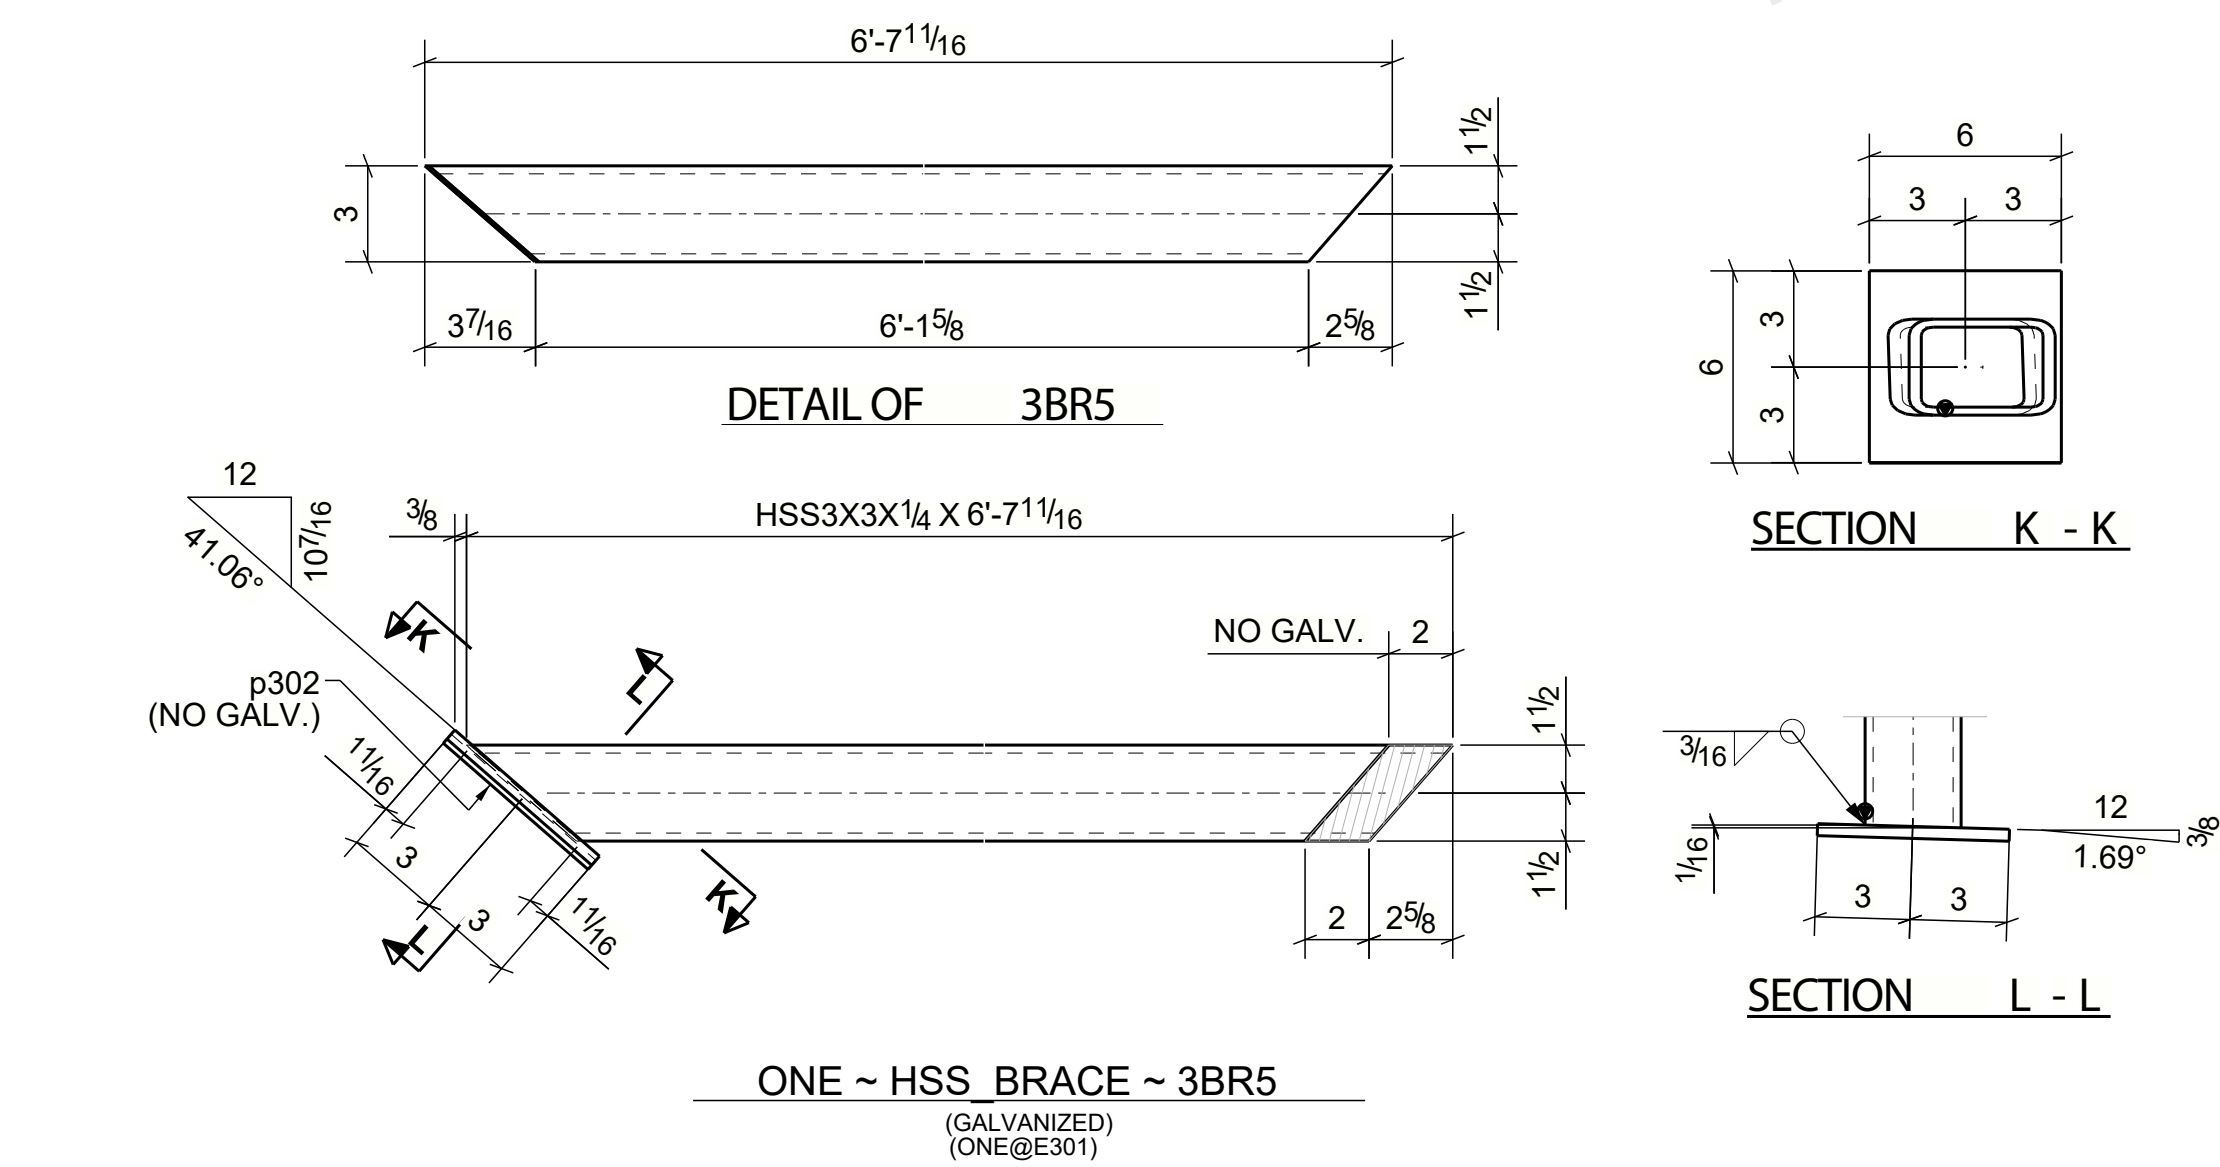
| BILL OF MATERIAL | | | | | | |
|---|---|---|---|---|---|---|
| 3BR1 | | 1 | HSS_BRACE | | | (GALV) |
| | 3BR1 | 1 | HSS3X3X1/4 | A500-GR.B | 6'-5 7/8" | (GALV) |
| | p302 | 1 | PL3/8"X6" | A36 | 0'-6" | |
| 3BR2 | | 2 | HSS_BRACE | | | (GALV) |
| | 3BR2 | 2 | HSS3X3X1/4 | A500-GR.B | 7'-11" | (GALV) |
| | p302 | 2 | PL3/8"X6" | A36 | 0'-6" | |
